Manhole Inspection Summary

Manhole # S23A1_007MH

Location Address: **Hollins Ferry Rd.**

Cross Street: **S.paca St.**

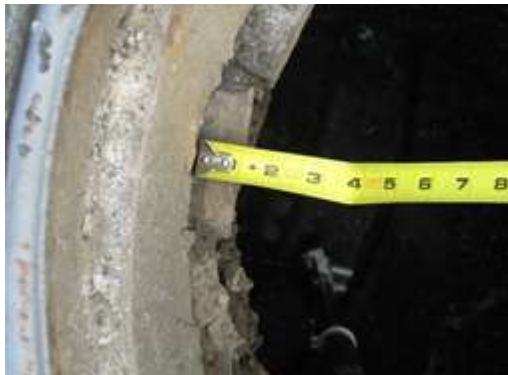
Defect 4

Frame Offset: **1** (in.) Condition: ☒ Sound ☐ Cracked ☐ Leaks

1 in Frame offset

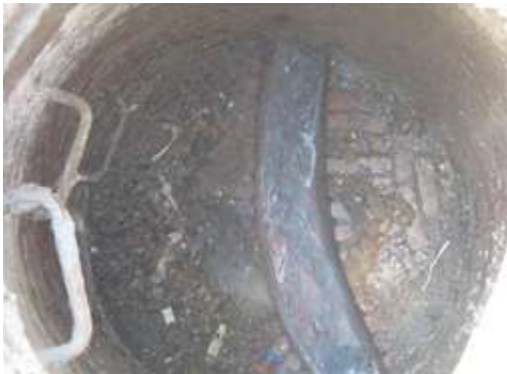
Defect

Steps Count: **4** Missing: **0** ☒ **Corroded**

corroded steps

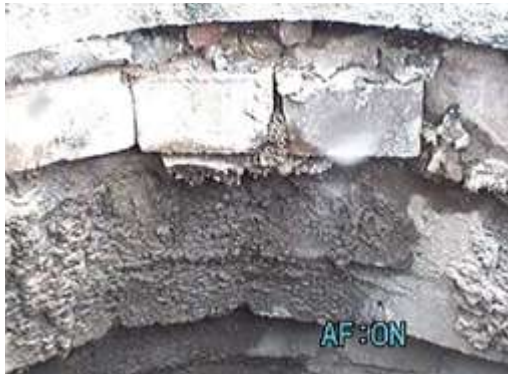
Defect 3

Condition: ☐ Sound ☐ Cracked ☐ Root Intrusion ☒ **Loose Brick** ☒ **Deteriorated**

Infiltration: ☐ None ☐ Joint ☐ Cracks ☒ **Mortar** ☐ Roots ☐ Wall

deteriorated chimney, loose bricks, Infiltration at chimney

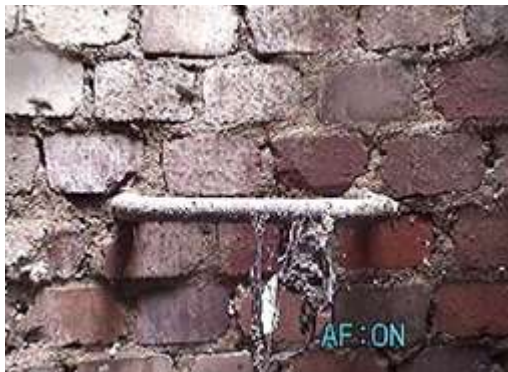
Defect 2

Surcharge ☒ **Evidence Of Surcharge** Depth: **3.5** (ft.) ☐ Active Surcharge Present

Surcharge evidence

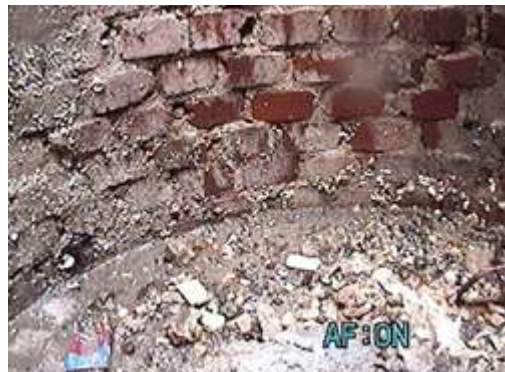
Defect 1

Condition: ☐ Sound ☐ Cracked ☐ Root Intrusion ☐ Deteriorated ☐ Leaks ☒ **Debris**

Debris on bench

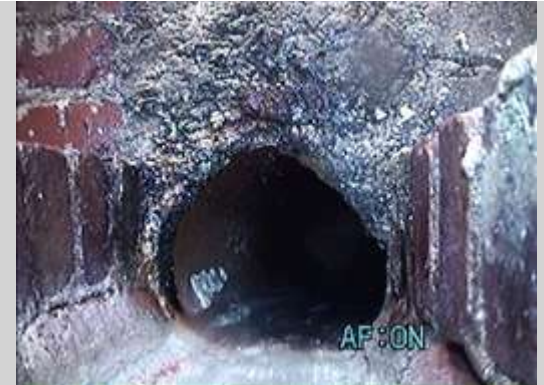
12 O'Clock Outflow

8 in. Circular Gravity Sewer
Pipe Out @ 12 O'Clock

Pipe Height: **8.4** (in.) Rod and Bar (Angled)
Pipe Material: **Clay** ☐ Pipe Lined
Invert Depth: **8.34** (ft.) Flow Characteristics: **Turbulent**
Deposits: ☒ None ☐ Mud ☐ Sludge ☐ Debris ☐ Grease
Silt Depth: **0** (in.) Deposits Extent:
Infiltration: **None** Pipe Seal Cond: **Sound**

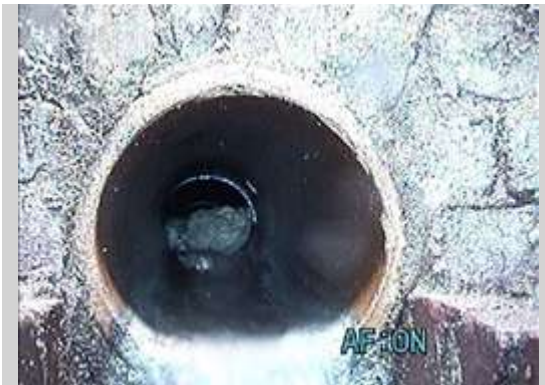
5 O'Clock Inflow

8 in. Circular Gravity Sewer
Pipe In @ 5 O'Clock

Pipe Height: **8.4** (in.) Rod and Bar (Angled)
Pipe Material: **Clay** ☐ Pipe Lined
Invert Depth: **7.90** (ft.) Flow Characteristics: **Turbulent**
Deposits: ☒ None ☐ Mud ☐ Sludge ☐ Debris ☐ Grease
Silt Depth: **0** (in.) Deposits Extent:
Infiltration: **None** Pipe Seal Cond: **Sound**
